Preliminary Study and Proposal for Restoring A Jesuit College at Saragossa, Spain

Rosa Bustamante, Benito Lauret, Juan Monjo and J.M. Valero
School of Architecture, Polytechnic University of Madrid, Spain

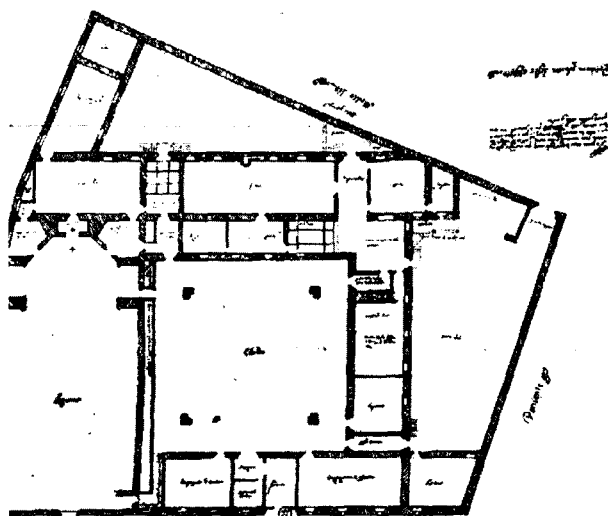
Figure 1 : First storey of San Carlos College, Saragossa, c. 1600 (Valléry-Radot), published in Saragossa at the time (Baltasar Gracián: 2001). Legend: 0 entrance; 1 Congregation of Knights; 2 Congregation of Schools; 3 latrines; 4 regular door; 5 pantry; 6 parlour; 7 refectory; 8 sacristy; 9 area “the way out to say mass”; 10 antesacristy; 11 latrines; 12 kitchen; 13 washroom; 14 stairway; 15 *de profundis*; 16 vegetable garden.

- the absence of side chapels, and therefore of columns and buttresses, confirms the preceding hypothesis (the dimensions given on the drawing in Aragonese yards are similar to the size of the present church, with a span between supports of approximately 21 m);

- as the two chapels at the head of the church form a transept, symmetry was maintained in the church design by creating polygonal areas, two antesacristies "*the way out to say mass*";

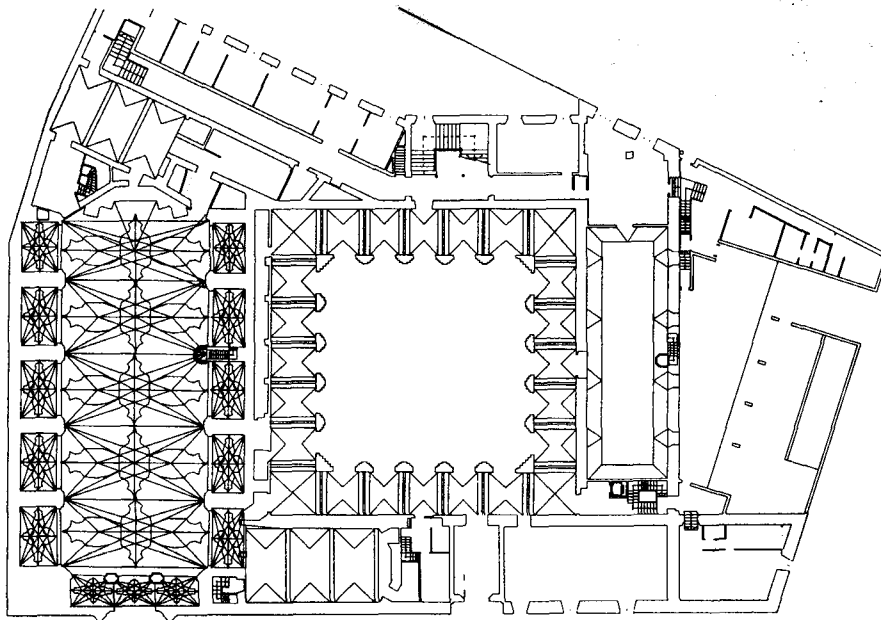
- while the drawing shows the sacristy perpendicular to the centreline of the church, it is actually perpendicular to San Jorge Street (Fig. 2); the explanation for this digression from the Jesuit model may be found in that the present sacristy, a vaulted polychrome nave with arch ribs, was built in part of a former Jewish castle, where, to make the most of the existing structure, the Jesuit monogram had to be tilted. And indeed, the oldest remains in the compound are located behind the church apse (Valero 2005), as attested for instance, by part of a walled-up ogee arch visible on the southeast buttress at the head of the church;

- the corridor to the upper choir confirms the inclusion of this element, but not of the portico at the entrance;
- due to the separation between the epistle (south) side and the cloister for men's and women's confessionals, the vaults over the latter had to be braced by columns detached from the epistle wall (see Fig. 2).

Figure 2 : Present plan view of San Carlos College at Saragossa. Church on one side of the block (San Jorge Street), cloister in the middle and other ancillary buildings to the south of the church.

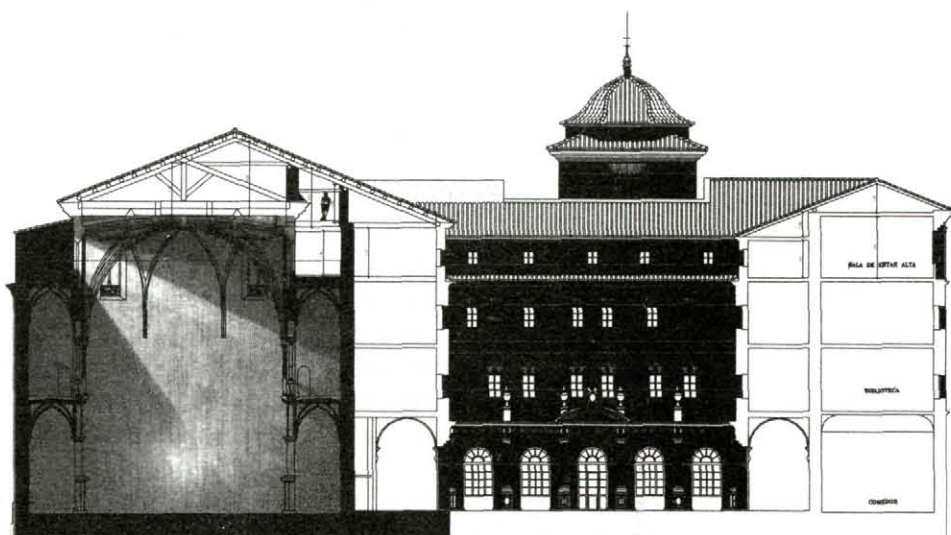
Figure 3 : Cross-section of the compound. Detail of the enlargement of the original roof and present state of interior lighting

On the occasion of the third storey enlargement, brick posts had to be erected on the original cornice (see Fig. 3), which is presently concealed by the roof, to support the extension of the roof over the south side of the central nave. Measuring 1 m high, this cornice, is similar to the one in the apse. From bottom up it consists of a quarter round, a cyma-recta, triglyphs alternating with tiny arches and another cyma-recta, all made of gauged brick and topped with two corbelled courses of brick.

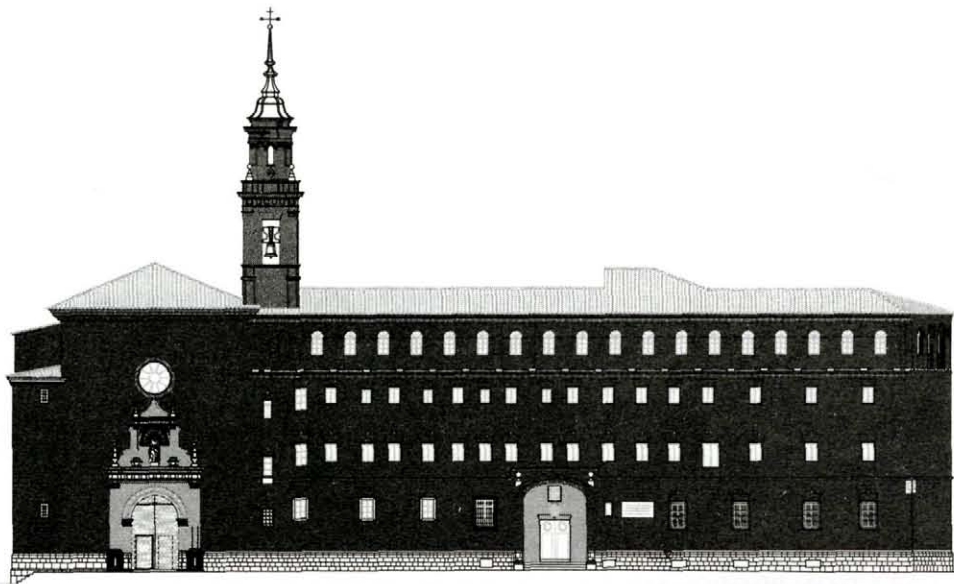
initiated by Brother Pablo Diego de Lacarre in 1723, in which the lustre on the vividly coloured stucco walls and the gilding on the wood reredos were extended to all the other constructional and decorative elements. Brother Lacarre's lavish interiors contrast with the austerity of the facade (Fig. 4).

Figure 4 : Church frontispiece and proposed restitution of the original roof.
To the right facade of the third storey enlargement to San Carlos Square.

After the survey conducted and in keeping with a philosophy that places a premium on essential aspects such as recovery of church roof symmetry and the upper windows for natural lighting, both of which are sufficiently documented to be original features, the approach chosen is to eliminate subsequent additions of questionable value that contradict and detract from fundamental characteristics of the monument's architecture (Figs 4 and 5).

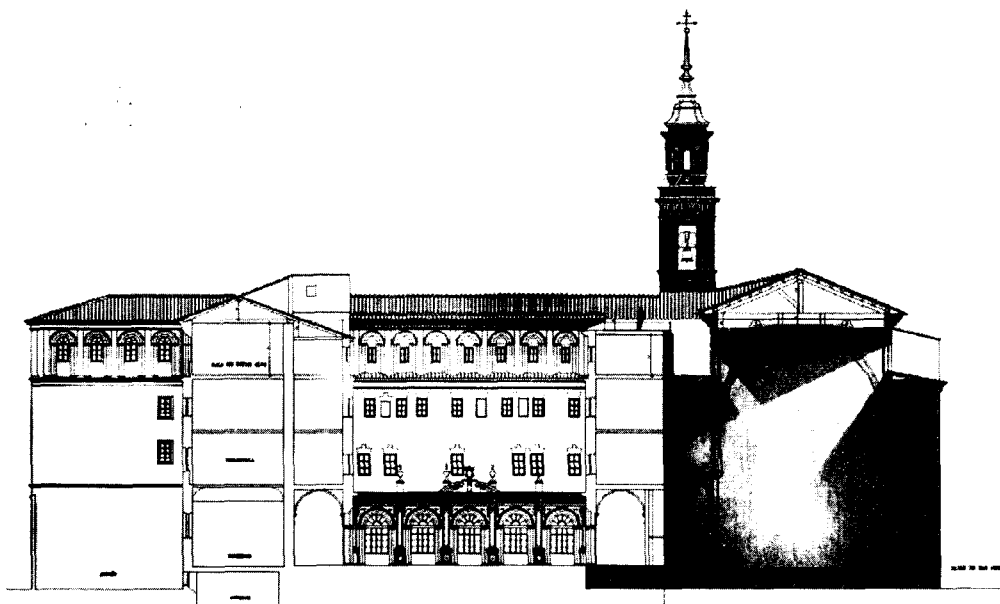
Figure 5 : Proposal for restitution of the natural lighting inside the church by rehabilitating the windows on the south or epistle side.

Such a tactic also provides natural lighting for the central nave of the church by exposing the upper windows in this area, presently concealed underneath the existing roof. To this end, skylights or an "English basement"-type arrangement will be used to eliminate any obstacle preventing daylight from reaching these windows (Fig. 5).
